PROTECTING A DESALTER WITH BELZONA 1391T

ID: 6455

Customer Location: Oil and Gas Asset Owner, China
Application Date: December 2016

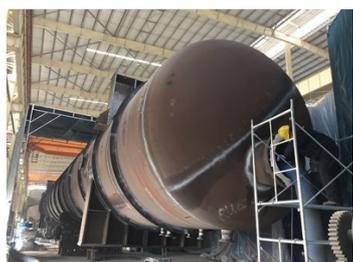
- * 1.Grit Blasting ,
- * 2.Nozzle Insert ,
- * 3.2nd Coating ,
- * 4.Spark Test ,

Application was carried out in accordance with Belzona Know-How System Leaflet TCC-5 and TCC-16b . Preformed nozzle inserts were created and bonded into small diameter nozzles to ensure continuity of protection.
