Belzona Repairs and Protects Screw conveyor

Customer Location: Wastewater Treatment Plant, Bialystok
Poland

Application: SHM-Solids Handling Machinery

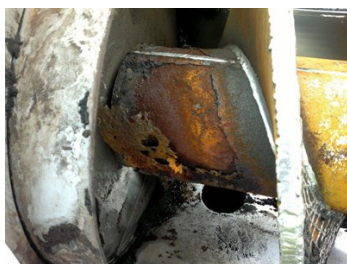
The new screw conveyor suffered surprisingly fast wear by erosion and bi-metallic corrosion. The shaft of the screw conveyor had been topped with a stainless steel sheet to protect it from corrosion. However, after less than a year of operation the steel was worn from the surface of the shaft. In addition to the aggression of chemical sludge, it reaches a very high temperature of approx. 120 degrees Celsius.

- * 1.Screw conveyor before application ,
- * 2.Visible effects of galvanic corrosion ,
- * 3.Application of Belzona 9811 and Belzona 1511 ,
- * 4.View after grouting with Belzona 1813 ,

The application was carried out in accordance with Belzona System leaflet SHM-14. The surface of the shaft was blasted and Belzona 9811 tiles were bonded to the surface of the shaft using Belzona 1511. The tiles were grouted using Belzona 1813.
