MUFF COUPLING REPAIR WITH BELZONA

Industry: *Marine*
Application: *MPT-Mechanical Power Transmission*

Customer Location: *Maritime company, Egypt.*
Application Date: *September 2005.*

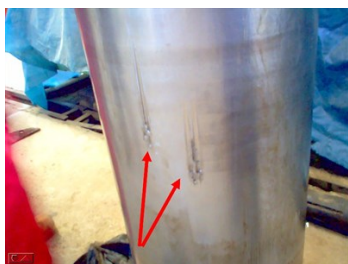
Scratches on inner and outer surfaces of coupling.

- * Scratches on the inner part of the Muff Coupling ,
- * Filling the scratches with Belzona® 1111 ,
- * Belzona® 1111 applied to the coupling ,
- * Application completed ,

Application was carried out using a modification of Belzona Know-How System Leaflet MPT-13. The scratches were rebuilt then the surface was finished to size.

Belzona repaired all scratches without heat distortion and machining. It was installed using 1500 bar oil pressure which the Belzona was able to withstand.
