BELZONA PUMP RESTORATION

ID: 652

Customer Location: Water Plant, Egypt
Application Date: December 2004

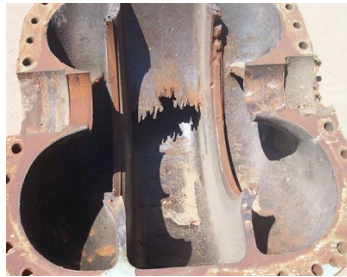
The four pumps were very badly eroded and corroded. As a result, the flow rate was much lower than the normal flow rate.

- * General view of the four deteriorated pumps ,
- * Corroded-eroded pump and cut water ,
- * Rebuilding the eroded areas inside the pump ,
- * Completed application ,

Each of the four pumps was facing many problems in the cutwater and the wear ring seats which decreased the efficiency of the plant. Instead of buying new pumps Belzona was used to repair the old pumps providing extra protection while restoring the plants power without resorting to buying new expensive units.
