BELZONA REPAIR BY ROPE ACCESS

Industry: Oil & Gas
Application: SOS-Ships and Offshore Structures

Customer Location: Offshore Platform, Indonesia
Application Date: August 2005

8-inch diameter Neoprene coated Riser Pipe

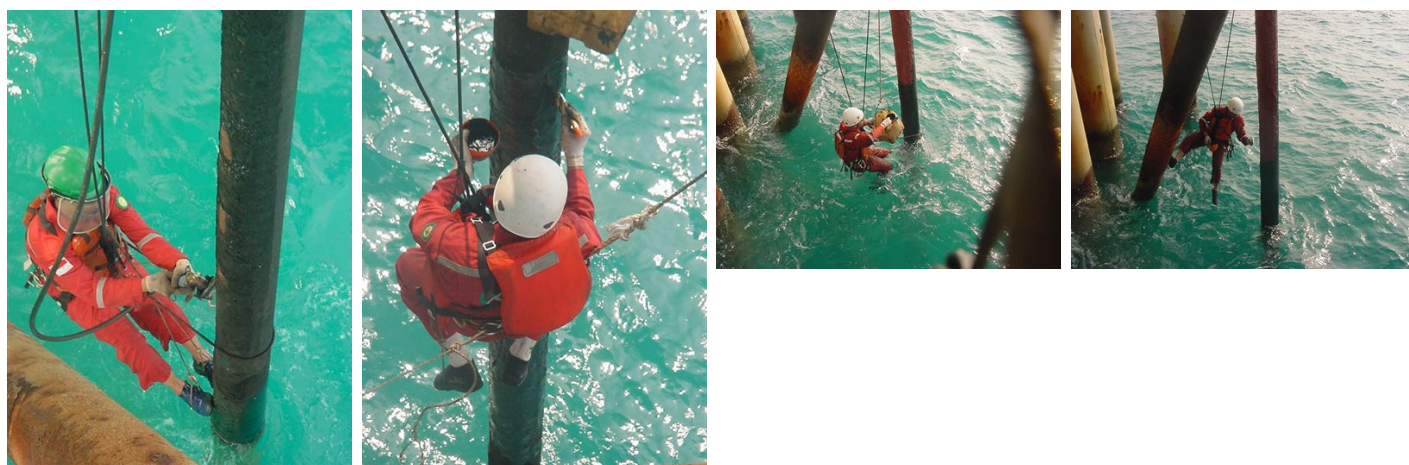
Damage on Neoprene coating and corrosion in splash zone.

- * Preparation of existing Neoprene ,
- * Rebuild and coating with Belzona® 2211 and Belzona® 2121 ,
- * Coating splashing zone with Belzona® 5831 ,
- * Complete application ,

Application carried out in accordance with modified Belzona Know-How System Leaflet VPF-3. Existing Neoprene repaired and coated with Belzona® 2211 and Belzona® 2121. Splash zone protected with Belzona® 5831.
