BELZONA RESTORES CORRODED COOLER COVER

ID: 656

Cooler cover

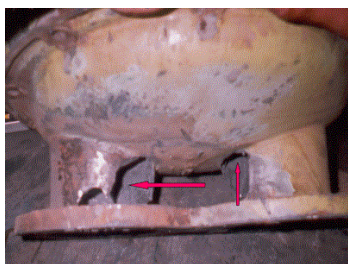
Both the inlet and outlet pipes on the cooler were totally corroded through with large holes in the body of the cover.

- * The cover ,
- * Rebuilding the division bar completed ,
- * Rebuilding the inlet and outlet pipes ,
- * Cover coated to provide overall protection ,

Application was carried out in accordance with Belzona Know-How System Leaflets HEX-3 & HEX-5.

Instead of being scrapped Belzona restored this cover, getting it back into service with added protection from future corrosion.
