# BELZONA RESTORES CORRODED COOLER COVER

Industry: *Marine*  
Application: *HEX-Heat Exchangers*  
Substrate: *Steel*  
Products: \* *Belzona® 1311 (Ceramic R-Metal)* ,  
\* *Belzona® 1321 (Ceramic S-Metal)* ,

Customer Location: *Maritime company, Egypt*  
Application Date: *March 2005*

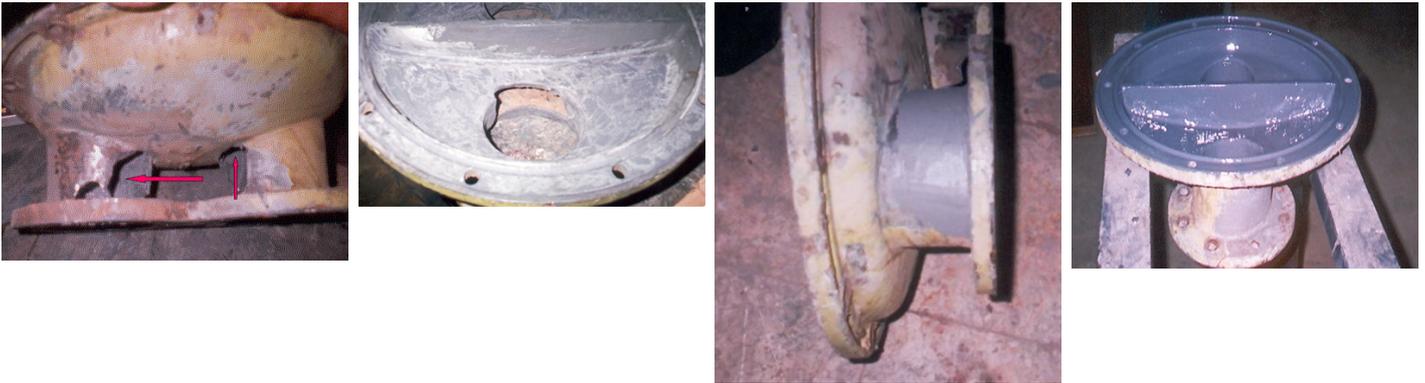
## Photograph Descriptions

*Both the inlet and outlet pipes on the cooler were totally corroded through with large holes in the body of the cover.*

- \* The cover ,
- \* Rebuilding the division bar completed ,
- \* Rebuilding the inlet and outlet pipes ,
- \* Cover coated to provide overall protection ,

Application was carried out in accordance with Belzona Know-How System Leaflets HEX-3 & HEX-5.

Instead of being scrapped Belzona restored this cover, getting it back into service with added protection from future corrosion.
