# BELZONA® 1341 STANDS THE TEST OF TIME AT IRRIGATION PLANT

Customer Location: Irrigation Plant, North Queensland,  
Australia

Application: CEP-Centrifugal Pumps

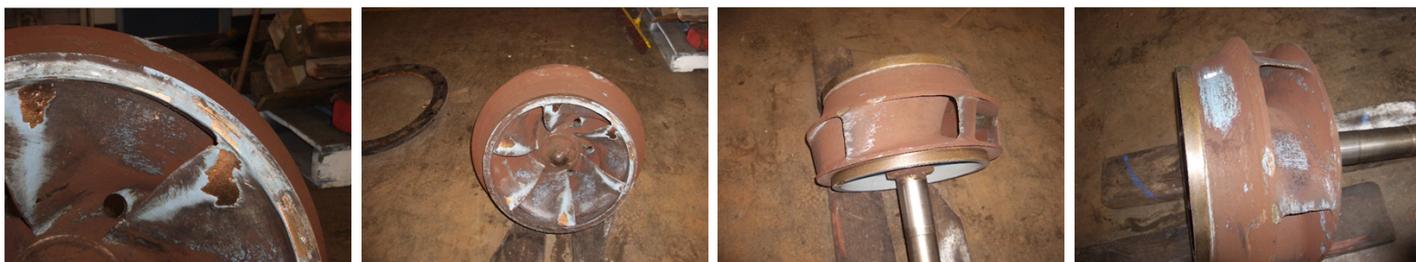
Due to general erosion/corrosion to this impellor, the customer requested sacrificial coating to protect the equipment.

- \* Close up of the impellor, showing localised cavitation damage ,
- \* The impellor easily patch repaired with Belzona® 1341 ,
- \* Deposits from the river water evident on the Belzona coating ,
- \* The deposits removed easily with a paper towel ,

Recent inspection of the impellor revealed, that after 12 years of hard work following the Belzona® 1341 application, wear is minimal. Although there is a brown deposit left on the impellor from the river, it is very easily removed with a paper towel.
