BELZONA RENEWS DEFORMED CONVEYOR DRIVE DRUM

ID: 663

Application: *SHM-Solids Handling Machinery*

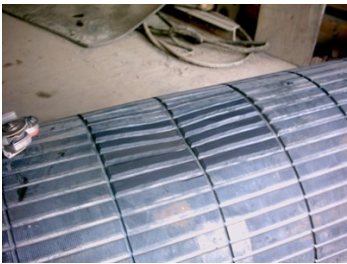
The drive drum had a 15 mm rubber cover. The surface of the drum was mechanically deformed during transportation with fork lift truck.

* View of the damaged drum Preparing the deformed area Finished application ,

Application was carried out in accordance with Belzona Know-How System Leaflet SHM-9.
