# BELZONA RENEWS DEFORMED CONVEYOR DRIVE DRUM

ID: 663

Rubber clad conveyor drive drum.

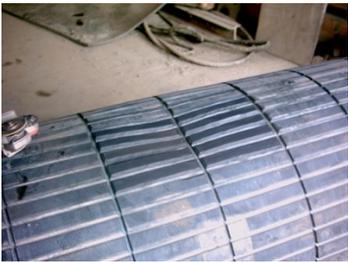
*The drive drum had a 15 mm rubber cover. The surface of the drum was mechanically deformed during transportation with fork lift truck.*

\* View of the damaged drum Preparing the deformed area Finished application ,
