BELZONA RENEWS DEFORMED CONVEYOR DRIVE DRUM

Industry: Mining & Quarrying
Application: SHM-Solids Handling Machinery

Customer Location: Coal mine in Macedonia
Application Date: August 2002

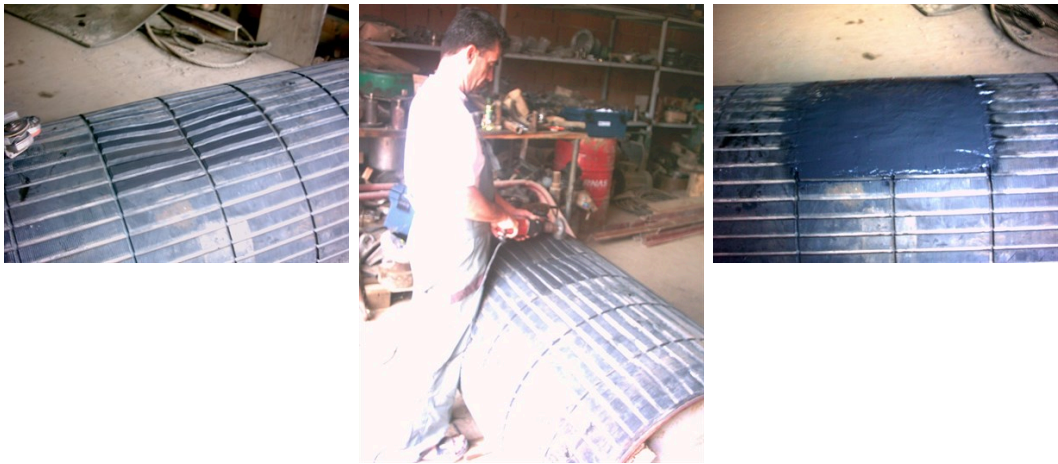
The drive drum had a 15 mm rubber cover. The surface of the drum was mechanically deformed during transportation with fork lift truck.

* View of the damaged drum Preparing the deformed area Finished application ,

Application was carried out in accordance with Belzona Know-How System Leaflet SHM-9.

This was the only solution for rebuilding the deformed drum surface. The success of the repair lead to similar applications carried out on two more conveyor belt drums.
