BELZONA KEEPS COOLING WATER PUMP RUNNING

ID: 664

Customer Location: Coal power plant in Macedonia
Application Date: September 1999

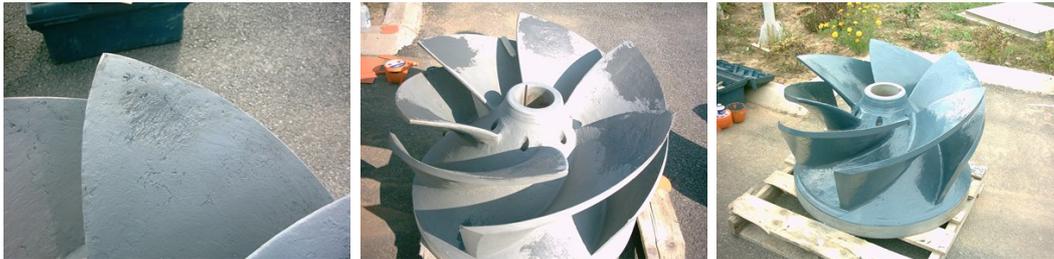
Cavitation-erosion damage on the impellers

- * Eroded pump blades ,
- * Filled pump blades with Belzona® 1311 ,
- * Finishing with Belzona® 1321 ,

Cavitation reduces thickness of the blades, increasing risk of their breaking. Belzona® 1311 rebuild restored impellor profiles. After applying of Belzona® 1321, the power consumption decreased and the flow increased. Replacing the pump costs about 50.000,00 EUR and it takes 60 days. This application had been done twice on two impellers.

Application was carried out in accordance with Belzona Know-How System Leaflets CEP-5 and CEP-7.
