# BELZONA KEEPS WHEAT REFINER RUNNING

ID: 665

Drive shaft on Wheat refiner

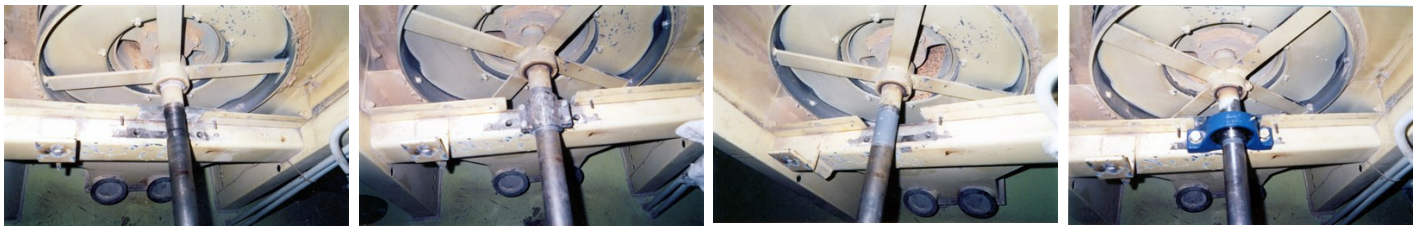
Bearing failure damaged the shaft.

- \* The damage on the shaft is evident ,
- \* The former was used to rebuild the shaft ,
- \* The former was removed after Belzona® 1221 had cured ,
- \* Bearing re-assembled ,

Application was carried out in accordance with Belzona Know-How System Leaflet MPT-2. Two part mold was prepared before-hand to restore correct shaft diameter.

The application was done in few hours. Conventional welding method could cause deformation. Delivery time of a new shaft was 4-6 weeks. New shaft costs 3,700 EUR. All work was finished for 150 EUR. This application was done twice. The shaft still running today.
