BELZONA KEEPS WHEAT REFINER RUNNING

ID: 665

Drive shaft on Wheat refiner

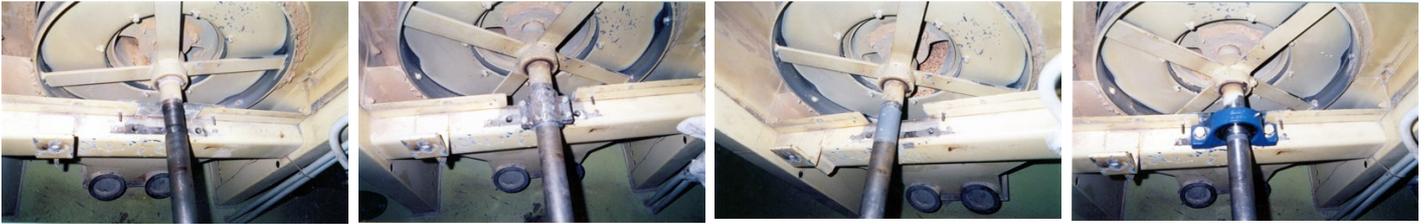
Bearing failure damaged the shaft.

- * The damage on the shaft is evident ,
- * The former was used to rebuild the shaft ,
- * The former was removed after Belzona® 1221 had cured ,
- * Bearing re-assembled ,

Application was carried out in accordance with Belzona Know-How System Leaflet MPT-2. Two part mold was prepared before-hand to restore correct shaft diameter.

The application was done in few hours. Conventional welding method could cause deformation. Delivery time of a new shaft was 4-6 weeks. New shaft costs 3,700 EUR. All work was finished for 150 EUR. This application was done twice. The shaft still running today.
