BELZONA BUND SEALING TO ENSURE ENVIRONMENTAL COMPLIANCE

Industry: Commercial Facilities
Application: TCC-Tanks and Chemical Containment Areas
Substrate: Concrete
Products: * Belzona® 4141 (Magma-Build) ,
* Belzona® 4131 (Magma-Screed) ,
* Belzona® 5231 (SG Laminate) ,

Customer Location: Commercial Vehicle Repair Shop
Application Date: September 2005

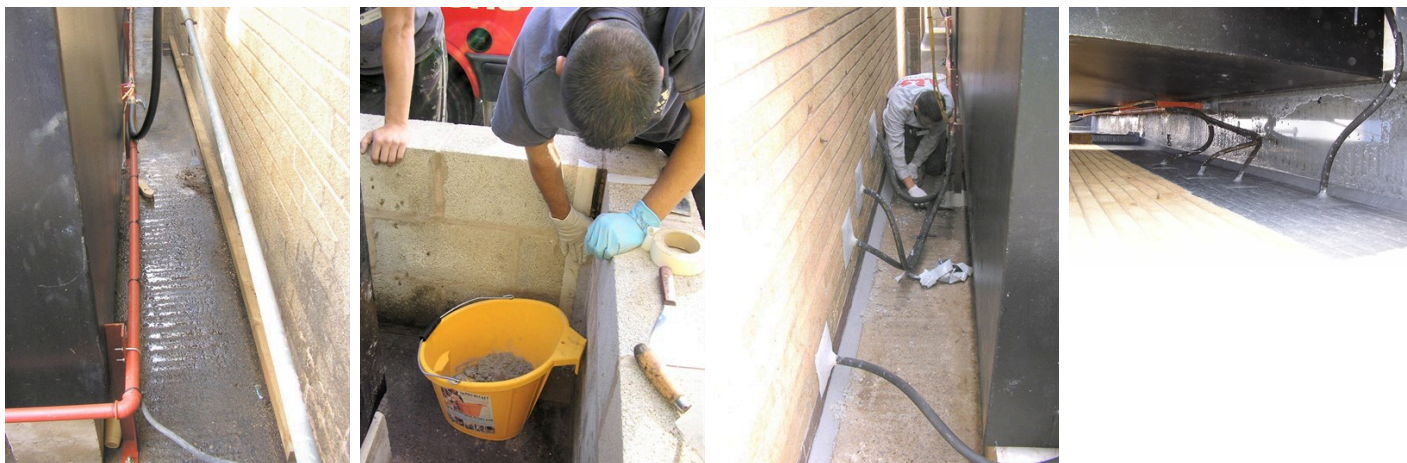
Photograph Descriptions

Legislation non-compliance due to newly constructed bund being porous due to construction materials, concrete base and 9 inch concrete block walls.

- * Porous bund floor and side wall ,
- * Introduction of wall to wall fillets ,
- * Wall penetrations sealed and fillet complete ,
- * Finished job ,

Application carried out in accordance with Belzona Know-How System Leaflet TCC-15.

Original condition of bund meant that it failed the Environmental compliance guidelines (PPG 2). Belzona materials were easily applied to give a long term impermeable coating system.
