BELZONA REPAIRS LARGE HYDRAULIC RAM

ID: 668

Customer Location: *Hot Roll Mill for Steel Sheets, Macedonia*
Application Date: *October 2005*

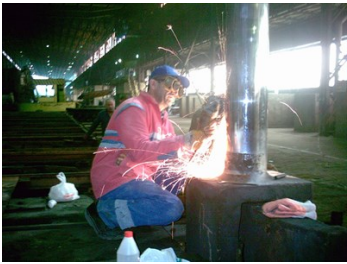
Many years in service had caused large vertical gouges to be worn into the ram

- * Surface preparation ,
- * Ready for application of Belzona ,
- * Finished repair ,

Application was carried out in accordance with Belzona Know-How System Leaflet MPT-3.
