BELZONA SAVES ANIMAL FEED MANUFACTURER

Application: MPT-Mechanical Power Transmission

Products: * Belzona® 1131 (Bearing Metal),

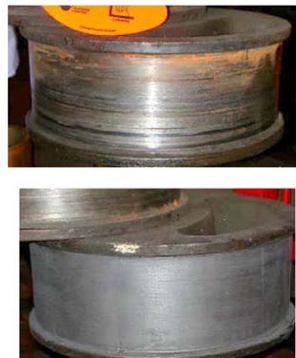
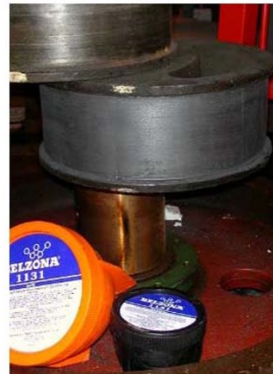
Photograph Descriptions

With one of two spray dry pumps down, plant production was reduced by half.

- * Crankshaft ,
- * Close up of scored & repaired bottom journal ,
- * Another close up of the repair ,

Crankshaft was scored due to debris and low oil levels in the sump.

Application carried out in accordance with Belzona System Leaflet MPT-9. Belzona® 1131 was hand applied to the scored journal and subsequently hand finished with fine emery.

speed cranks but highly successful in this application. Since startup, sump was run dry of oil twice with no damage to the Belzona® 1131.
