BELZONA SAVES ANIMAL FEED MANUFACTURER

ID: 669

Application: *MPT-Mechanical Power Transmission*

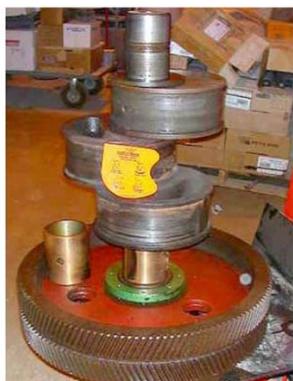
- * Crankshaft ,
- * Close up of scored & repaired bottom journal ,
- * Another close up of the repair ,

Crankshaft was scored due to debris and low oil levels in the sump.

Application carried out in accordance with Belzona System Leaflet MPT-9. Belzona® 1131 was hand applied to the scored journal and subsequently hand finished with fine emery.
