BELZONA SAVES ANIMAL FEED MANUFACTURER

Application: MPT-Mechanical Power Transmission

Products: * Belzona® 1131 (Bearing Metal),

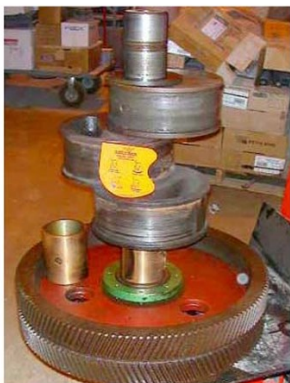
- * Crankshaft ,
- * Close up of scored & repaired bottom journal ,
- * Another close up of the repair ,

Crankshaft was scored due to debris and low oil levels in the sump.

Application carried out in accordance with Belzona System Leaflet MPT-9. Belzona® 1131 was hand applied to the scored journal and subsequently hand finished with fine emery.
