# BELZONA SAVES ANIMAL FEED MANUFACTURER

Application: *MPT-Mechanical Power Transmission*

Products: *\* Belzona® 1131 (Bearing Metal),*

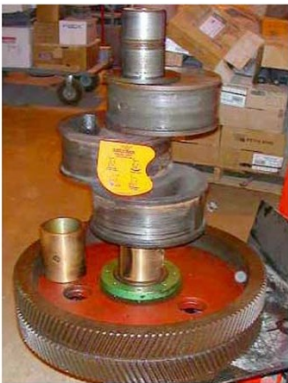
- \* Crankshaft ,
- \* Close up of scored & repaired bottom journal ,
- \* Another close up of the repair ,

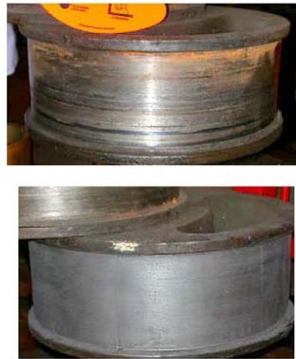
Crankshaft was scored due to debris and low oil levels in the sump.

Application carried out in accordance with Belzona System Leaflet MPT-9. Belzona® 1131 was hand applied to the scored journal and subsequently hand finished with fine emery.
