BELZONA SCRUBBER HEADER PATCHED

ID: 67

Customer Location: Power Plant in North Texas
Application Date: 1994

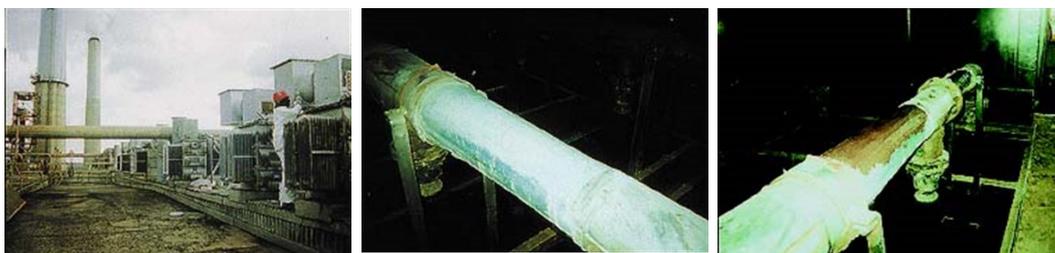
Scrubber nozzles spray lime slurry to neutralize flue gas. Nozzle gets plugged or worn, redirecting a side stream that tears holes in fiberglass headers.

- * A view in the plant ,
- * Fiberglass header in scrubber unit ,
- * Header patched with Belzona® 1811 ,

The application was carried out in accordance with a modified version of Belzona Know-How Leaflet TCC-3.

The application saves replacement (fabrication) of the header. Ongoing repair, as needed since 1994.
