BELZONA STOPS WINDOW LEAKS

ID: 670

Customer Location: Community College, St. Charles,
Missouri USA

Application: RPA-Roof Problem Areas

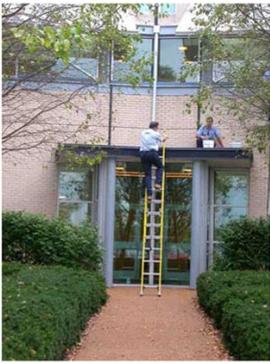
The bottoms of the windows had almost imperceptible openings allowing wind blown water to enter and travel to the entry canopy staining the ceiling tile.

- * View of windows above entry canopy. ,
- * Close up of the problem and start of the repair. ,
- * Finished repair. ,
