# BELZONA STOPS WINDOW LEAKS

**Customer Location:** Community College, St. Charles,  
Missouri USA

**Application:** RPA-Roof Problem Areas

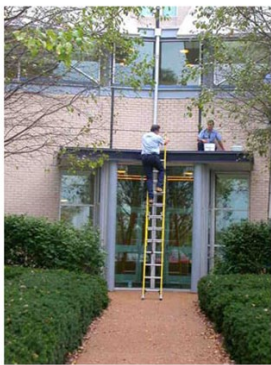
The bottoms of the windows had almost imperceptible openings allowing wind blown water to enter and travel to the entry canopy staining the ceiling tile.

- \* View of windows above entry canopy. ,
- \* Close up of the problem and start of the repair. ,
- \* Finished repair. ,
