WASTE WATER PLANT DIGESTER SEALED WITH BELZONA

ID: 671

Customer Location: City of Hannibal, Missouri USA
Application Date: August 2003

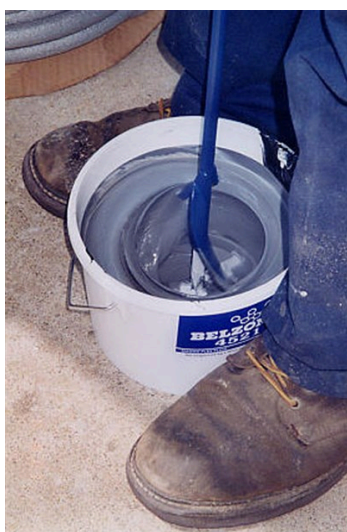
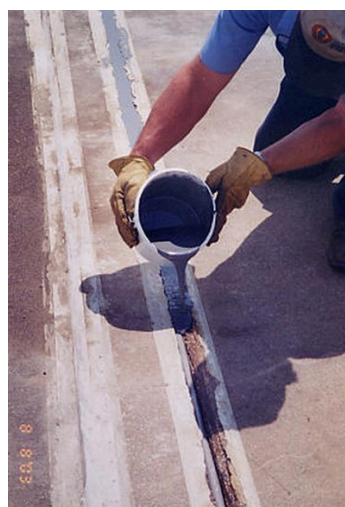
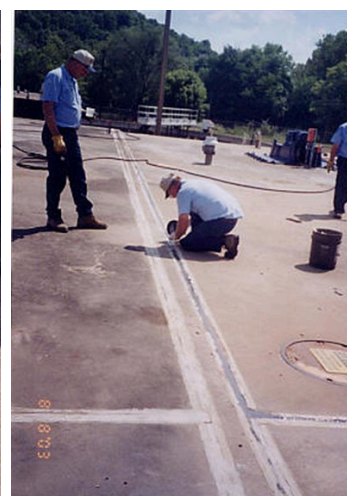
Photograph Descriptions

Loss of oxygen rich gas caused customer to re-enrich with oxygen monthly. Design conditions called for re-enrichment only three times per year.

- * Overview of the digester top. ,
- * Mixing Belzona® 4521. ,
- * Casting the joint. ,
- * Close up of joint. ,

Leaking expansion joints at digester top

Application was carried out in accordance with Belzona Know-How System Leaflet TCC-12.

Yearly cost for enrichment dropped from \$72,000 to \$18,000 after the repairs. This success led to overhaul of several water plant pumps.
