WASTE WATER PLANT DIGESTER SEALED WITH BELZONA

ID: 671

Customer Location: City of Hannibal, Missouri USA
Application Date: August 2003

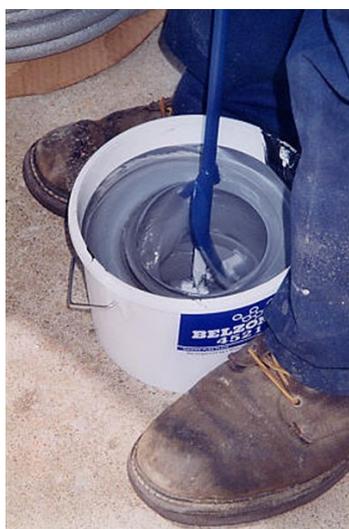
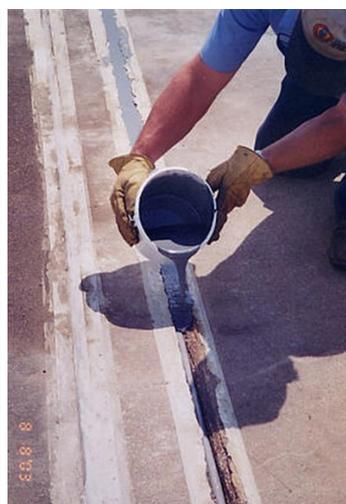
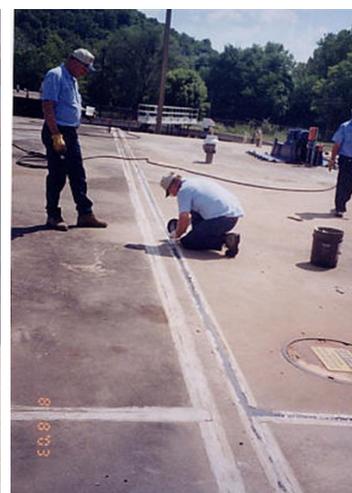
- * Overview of the digester top. ,
- * Mixing Belzona® 4521. ,
- * Casting the joint. ,
- * Close up of joint. ,

Leaking expansion joints at digester top

Application was carried out in accordance with Belzona Know-How System Leaflet TCC-12.

Yearly cost for enrichment dropped from \$72,000 to \$18,000 after the repairs. This success led to overhaul of several water plant pumps.
