# BELZONA CEMENT HOPPER FLANGE REPAIR

ID: 673

Customer Location: *Cement Works, Usje, Macedonia*  
Application Date: *August 2004*

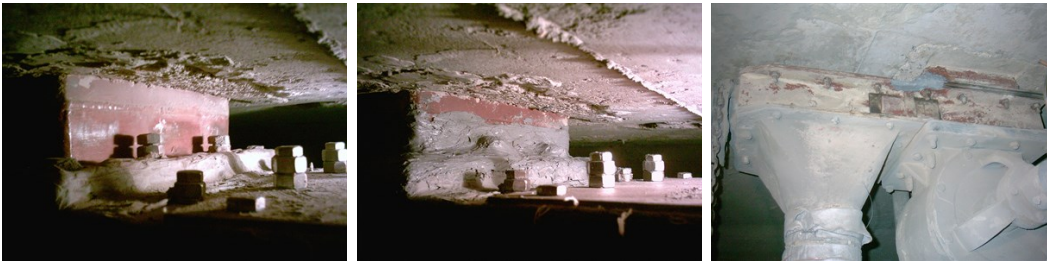
*Failure of the rubber gasket allowed cement to fall from the hopper when it was being emptied.*

- \* Application situation ,
- \* During application of Belzona ,
- \* Finished application ,

Cement hopper flange

Application was carried out in accordance with Belzona Know-How System Leaflet SOS-10b.

This large hopper was full of cement so it was not possible to dismantle the flange and change the gasket, therefore, the Belzona solution of sealing the flange again in-situ was the only quick and cost effective solution.
