BELZONA REBUILDS AND PROTECTS ONBOARD SEAWATER STRAINER

ID: 676

Sea water strainer

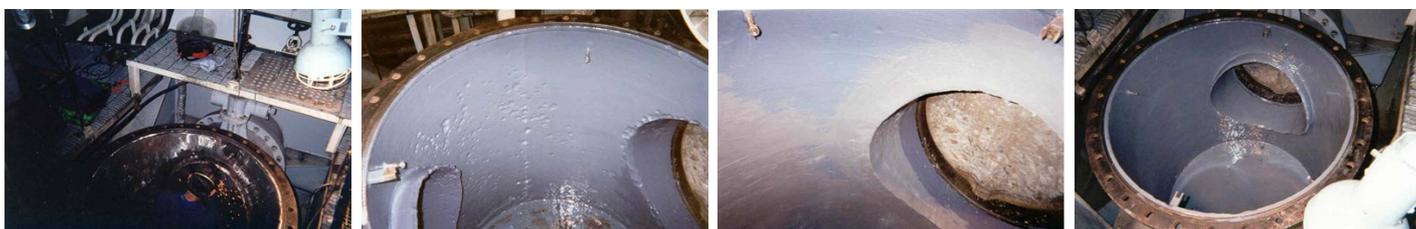
Photograph Descriptions

This vessel was less than three years old. Because of impurities in the metal used, the vessel had suffered major metal loss through bi-metallic corrosion. Up to a 1/4 inch of thickness had been lost in various places

- * View of vessel with surface preparation in progress ,
- * Application of first coat Belzona® 1321 ,
- * Application of Belzona® 1311 to all eroded areas ,
- * Application of final coat of Belzona® 1321 ,

Application was carried out in accordance with Belzona Know-How System Leaflet TCC-5.

Failure to attend to the problem would have led to the vessel being condemned, necessitating replacement. The use of Belzona allowed for onboard repairs which would extend the vessel's life for several years.
