# BELZONA REBUILDS A RUDDER PINTLE HOUSING

Customer Location: *Dry Docking Company - Vancouver,  
British Columbia - Canada*

Application: *SOS-Ships and Offshore Structures*

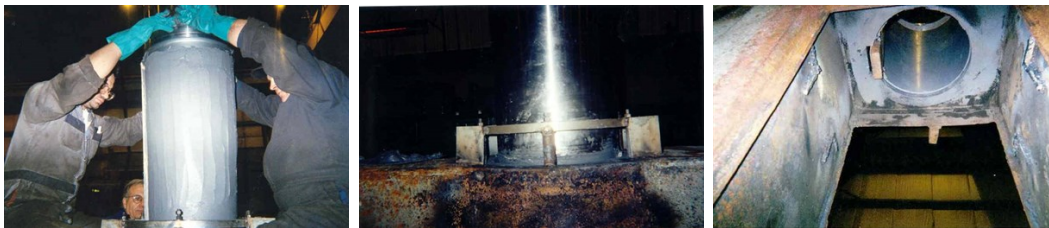
*A breakdown of the seal had allowed seawater to enter the housing causing bi-metallic corrosion.*

- \* View of coated rudder pintle one being inserted into the bore which has also been pre-coated. ,
- \* The pintle now completely inserted and extruded material removed. ,
- \* The pintle removed showing reformed bore giving 100% contact with the pintle. ,

The rudder pintle housing was oversized and needed to be rebuilt

Application carried out in accordance with Belzona Know-How System Leaflet SOS-3.

Rebuilding rudder pintle housing in this manner has three major advantages over a conventional repair. It eliminates stress cracking as no heat is involved. It reduces dry docking time and it solves the problem of bi-metallic corrosion.
