# BELZONA REBUILDS A RUDDER PINTLE HOUSING

ID: 677

Customer Location: Dry Docking Company - Vancouver,  
British Columbia - Canada

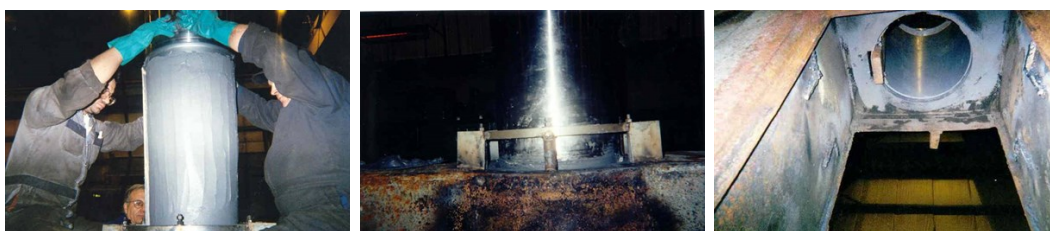
## Photograph Descriptions

- \* View of coated rudder pintle one being inserted into the bore which has also been pre-coated. ,
- \* The pintle now completely inserted and extruded material removed. ,
- \* The pintle removed showing reformed bore giving 100% contact with the pintle. ,

The rudder pintle housing was oversize and needed to be rebuilt

Application carried out in accordance with Belzona Know-How System Leaflet SOS-3.

Rebuilding rudder pintle housing in this manner has three major advantages over a conventional repair. It eliminates stress cracking as no heat is involved. It reduces dry docking time and it solves the problem of bi-metallic corrosion.
