BELZONA REBUILDS RUDDER PINTLE HOUSING

ID: 677

Application: SOS-Ships and Offshore Structures

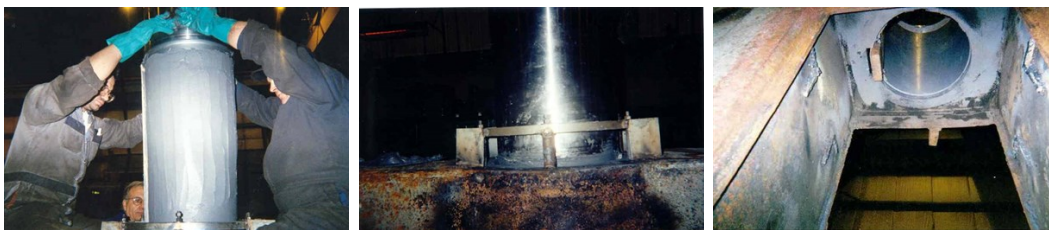
Photograph Descriptions

A breakdown of the seal had allowed seawater to enter the housing causing bi-metallic corrosion.

- * View of coated rudder pintle one being inserted into the bore which has also been pre-coated. ,
- * The pintle now completely inserted and extruded material removed. ,
- * The pintle removed showing reformed bore giving 100% contact with the pintle. ,

The rudder pintle housing was oversized and needed to be rebuilt

Application carried out in accordance with Belzona Know-How System Leaflet SOS-3.

Rebuilding rudder pintle housing in this manner has three major advantages over a conventional repair. It eliminates stress cracking as no heat is involved. It reduces dry docking time and it solves the problem of bi-metallic corrosion.
