BELZONA EXTENDS THE LIFE OF ID FANS

Customer Location: *Pulp and Paper Operation - Port Alberni,
British Columbia, Canada*

Application: *SHM-Solids Handling Machinery*

ID Fan housing

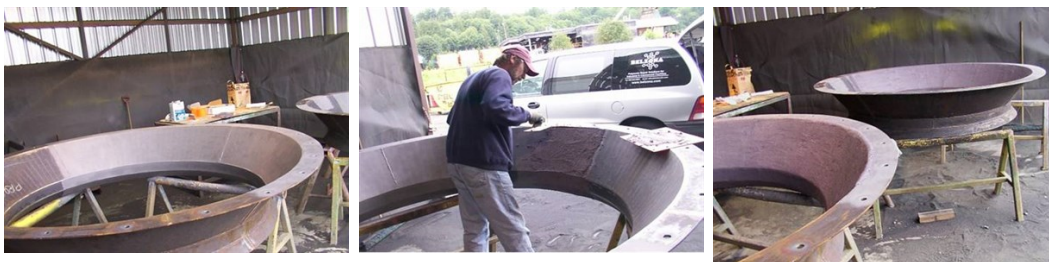
Photograph Descriptions

The ID fan housing would wear away necessitating replacement every two years at best.

- * Two new housings awaiting grit blasting ,
- * Application of Belzona® 1812 in progress ,
- * Application to first housing complete with second partially completed ,

Application carried out in accordance with Belzona Know How System Leaflet SHM-1.

An initial test on an original badly eroded unit proved the cost benefits of the application to the customer. With the Belzona product acting as a sacrificial wear surface minimal metal loss was recorded during the 12-month test period.
