BELZONA ELECTRICAL CONDUITS MADE SAFE

ID: 68

Customer Location: Coal Fired Power Plant in North Texas

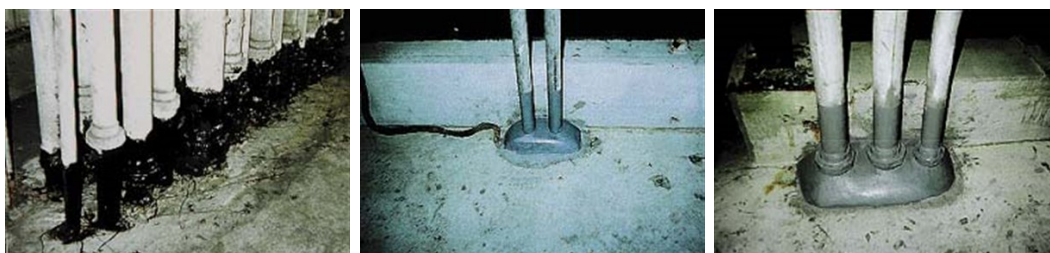
Photograph Descriptions

Sulfur in lignite (coal) combines with water (moisture) to form a weak sulfuric acid that corrodes the conduit.

- * Big bank of electrical conduit sealed with Belzona® 2111. ,
- * Another electrical conduit top dressed with Belzona® 4131. ,
- * Close-up view of conduit, also coated with Belzona® 3921 for corrosion protection. ,

If the conduit corrodes, the high voltage electrical cables (4000-6000 volts) inside pose a severe safety issue during cleaning. The Belzona application saved hundreds of thousands of dollars as the alternative to this repair is to run new electrical cables.
