BELZONA REBUILDS NON-SLIP SAFETY SYSTEM FOR INDOOR POOL AREA

Application: FPA-Floor Problem Areas

Substrate: Ceramic tiles

Customer Location: Whistler, BC, Canada

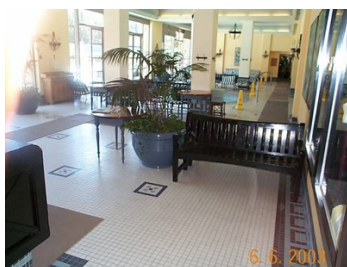
The tile surface was extremely slippery so customer had to use special non-slip mats to cover the walk areas. Non-slip mats did not give a good appearance to the atmosphere and smelled.

- * 1. View of Whistler Fairmont Resort Hotel ,
- * 2. A general view of the Health Club showing the floor mats in place ,
- * 3. When the product had cured, the area was swept with a broom and vacuumed. ,
- * 4. View of completed application covering approximately 700 sq.ft ,
