BELZONA REBUILDS NON-SLIP SAFETY SYSTEM FOR INDOOR POOL AREA

Customer Location: Whistler, BC, Canada

Application: FPA-Floor Problem Areas

Substrate: Ceramic tiles

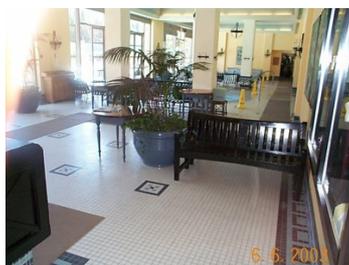
The tile surface was extremely slippery so customer had to use special non-slip mats to cover the walk areas. Non-slip mats did not give a good appearance to the atmosphere and smelled.

- * 1. View of Whistler Fairmont Resort Hotel ,
- * 2. A general view of the Health Club showing the floor mats in place ,
- * 3. When the product had cured, the area was swept with a broom and vacuumed. ,
- * 4. View of completed application covering approximately 700 sq.ft ,
