# BELZONA REBUILDS NON-SLIP SAFETY SYSTEM FOR INDOOR POOL AREA

ID: 682

Application: FPA-Floor Problem Areas

Tiled floor around Health Club pool area at the hotel Chain.

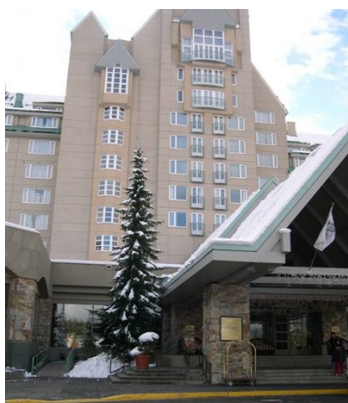
- \* 1. View of Whistler Fairmont Resort Hotel ,
- \* 2. A general view of the Health Club showing the floor mats in place ,
- \* 3. When the product had cured, the area was swept with a broom and vacuumed. ,
- \* 4. View of completed application covering approximately 700 sq.ft ,
