# BELZONA REBUILDS BEARING SURFACE ON PAPER MACHINE DRIVE

ID: 683

Industry: *Pulp & Paper*  
Application: *MPT-Mechanical Power Transmission*

Customer Location: *Pulp & Paper Operation, BC, Canada*  
Application Date: *2001*

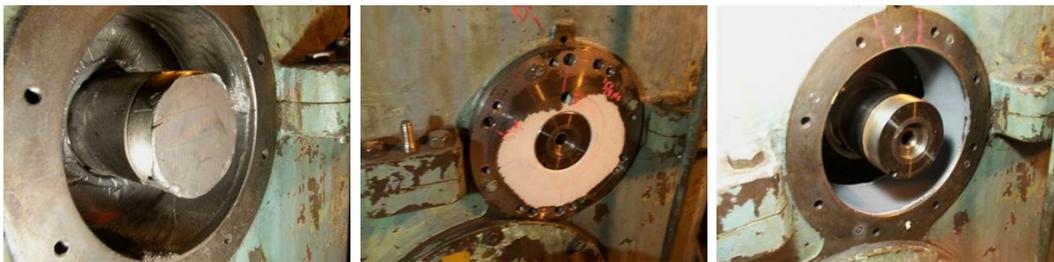
*The worn bearing fit on the paper machine drive was causing gear lash problems.*

- \* The bearing fit area ground to provide a rough surface and degreased with Belzona® 9111 ,
- \* The mold was positioned carefully before injecting Belzona® 1321 (Ceramic S Metal) ,
- \* The mold removed, revealing a perfectly formed new bearing surface ,

Application carried out in accordance with Belzona Know-How System Leaflet MPT-7.

There is a long and successful history of using this type of repair procedure in these facilities without any failures. This application also saves a great deal of downtime as there is no need to disassemble the housing.
