# BELZONA REBUILDS DAMAGED DRYER CAN JOURNAL IN 5 HOURS

Industry: *Pulp & Paper*  
Application: *MPT-Mechanical Power Transmission*

Customer Location: *Pulp & Paper Operation, BC, Canada*  
Application Date: *2004*

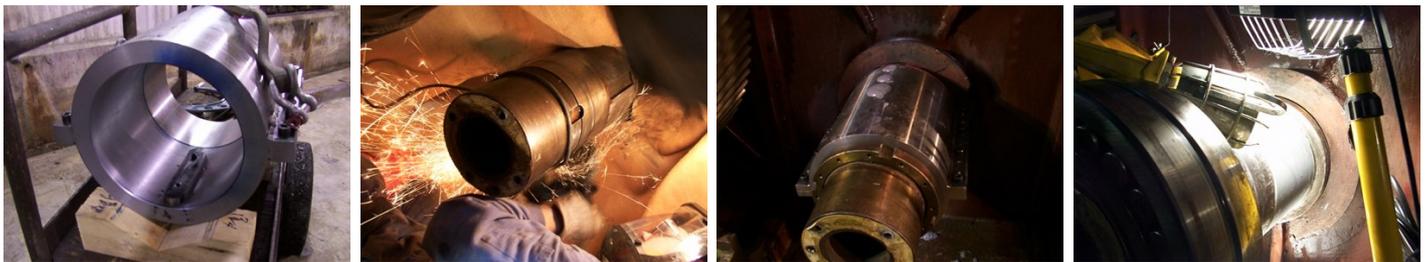
## Photograph Descriptions

*There was a fit problem with the gear causing excessive vibration when it was running*

- \* View of completed mold with new keyway fitted ,
- \* Grinding of the damaged journal underway ,
- \* The mold has been fitted and the Belzona 1391 HT Ceramic injected - see excess coming out of vent holes on top of mold. ,
- \* Mold removed revealing rebuilt journal ,

Damaged dryer can journal

Application carried out in accordance with Belzona Know-How System Leaflet MPT-2.

Because of the complexities associated with the intended application, the entire application procedure was pre-planned prior to a scheduled shutdown. As a result the application proceeded extremely smoothly.
