# BELZONA REBUILDS THE UNDERSIDE OF PULPMILL FLOOR

**Industry:** Pulp & Paper  
**Application:** FPA-Floor Problem Areas  
**Substrate:** Concrete and steel reinforcement bars  
**Products:** \* Belzona® 4141 (Magma Build) ,

**Customer Location:** Pulp & Paper Operation, BC, Canada  
**Application Date:** June 2003

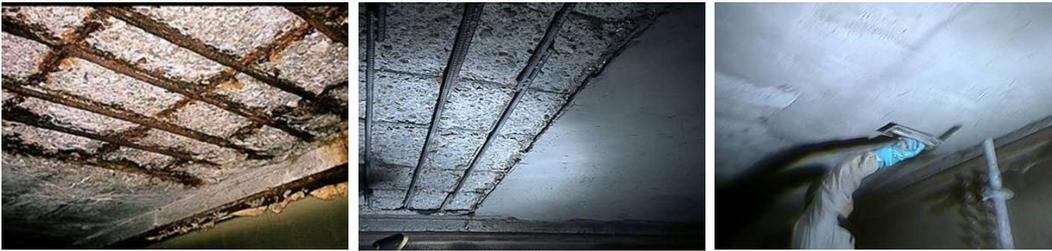
Moisture, vibration and impact from above had caused the underside of this concrete deck to spall badly leaving exposed corroding rebar.

- \* View of corroded rebar and spalled concrete underside ,
- \* A partially completed underside showing the unfinished section after grit blasting to remove all corrosion from the rebar ,
- \* Application in final stages of completion ,

Application carried out using a modified version of Belzona Know-How System Leaflet FPA-1.

Using Belzona 4141 Magma Build allowed the underside of the floor to be rebuilt in a single application without the need for forms saving many additional hours of downtime when compared with a conventional repair (Footnote: The damaged sections on the top side of the deck were rebuilt in 2002 with Belzona 4111 Magma Quartz and the complete deck area sealed with Belzona 5122 (Clear Cladding)).
