BELZONA REPAIRS HEAT EXCHANGER END COVERS

Customer Location: Cement Works, Usje, Macedonia
Application Date: March 2005

Heat Exchanger End Covers

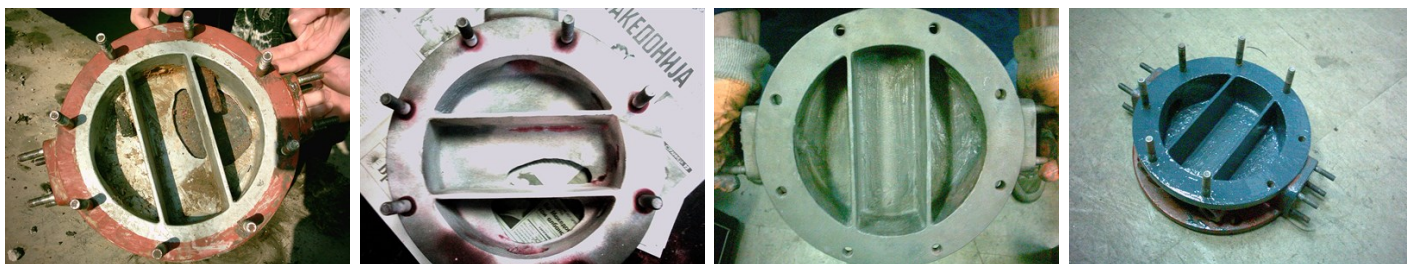
Photograph Descriptions

Holes and cracks had appeared on the end covers due to freezing water.

- * Damaged end cover ,
- * Surface preparation ,
- * Belzona® 1111 rebuild ,
- * Finished application with Belzona® 1321 coating ,

Application was carried out in accordance with Belzona Know-How System Leaflet HEX-5.

The customer had previously tried to weld a steel patch on to the end covers but it had failed. There were no new end covers in the warehouse and to order some would have meant 3-4 weeks of down time, thus the customer was delighted when Belzona solved the problem within two days, saving time and money.
