BELZONA REPAIRS CRACKED STEEL TUNNEL

ID: 692

Customer Location: *Cement Works, Usje, Macedonia*
Application Date: *September 2004*

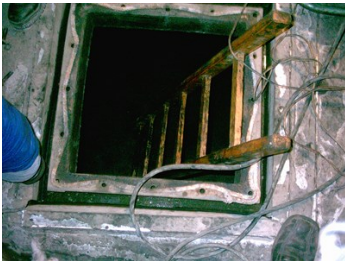
- * Steel tunnel entrance ,
- * Crack in steel tunnel ,
- * Belzona® 1221 repair ,

Steel Tunnel

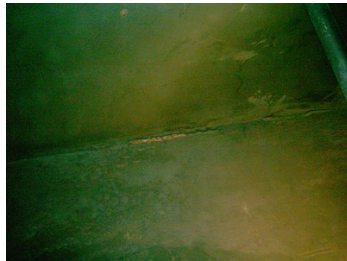
A 700mm long crack had appeared on the weld joint of the steel walls

The customer had tried to apply Silicone under the crack but it had failed within a month. This Belzona solution was designed to be a temporary solution to last 3 months until the plant was shut down when a weld repair could be carried out. The customer was very pleased with the outcome and the costs which were saved through not having to shut the plant down earlier than planned.
