# BELZONA REPAIR OF ACCESS RAMP AND STEPS

ID: 693

**Customer Location:** Local Council, United Kingdom  
**Application Date:** November 2004

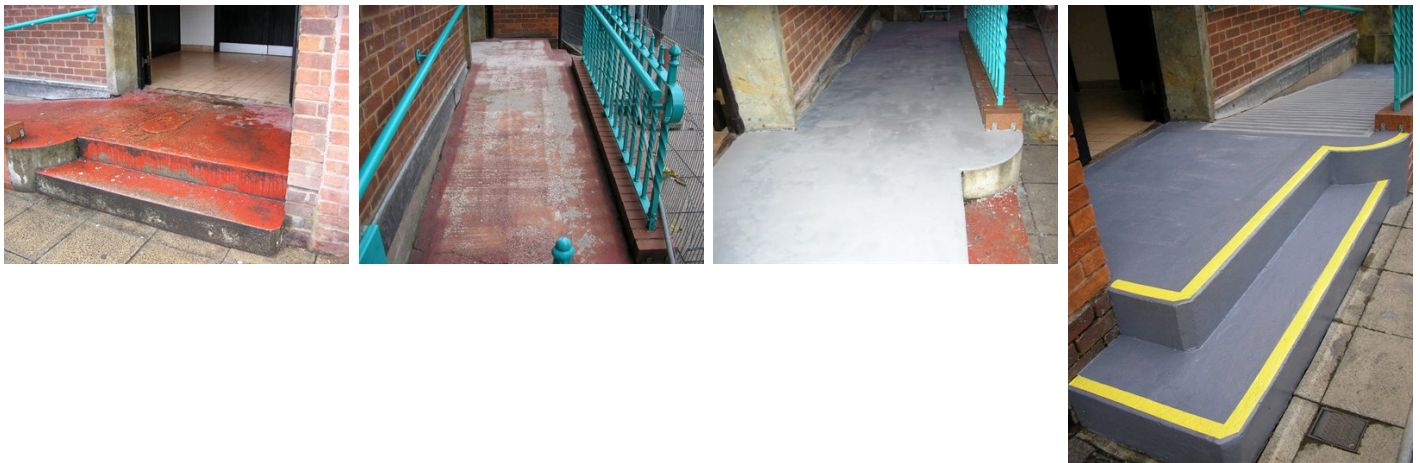
Much foot traffic and heavy weathering caused the steps and disabled access ramp of these public toilets to become damaged and worn. An inspection of the ramps according to the Disability Discrimination Act (DDA) found them to be unsafe and not compliant.

- \* Worn steps were a health and safety hazard ,
- \* Prepared surface ,
- \* Surface rebuilt with Belzona® 4131 ,
- \* Completed project ,

Heavily worn steps and disabled access ramp

Application was carried out in accordance with Belzona Know-How System Leaflet FPA-1.

The use of Belzona products was requested by the council in order to give a fast, long life, cost effective repair. The ability to bond and build up old concrete meant that the steps did not have to be completely removed and rebuilt. This ensured that the toilets would comply to the DDA standards. These heavily used toilets were quickly reopened to the public.
