# BELZONA WEATHERPROOFS AIRPORT FIRE STATION ROOF

Industry: *Buildings & Structures*  
Application: *RPA-Roof Problem Areas*  
Substrate: *Concrete*  
Products: *\* Belzona® 3131 (WG Membrane) ,*

Customer Location: *Airport, UK*  
Application Date: *May 2003*

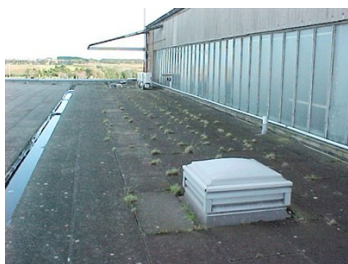
*This fire station roof was leaking and the local airport authority wanted to repair it and extend its life, rather than a full replacement.*

\* 1. Roof to be coated  
2. The roof after cleaning and surface preparation  
3. Coated roof  
4. Completed application ,

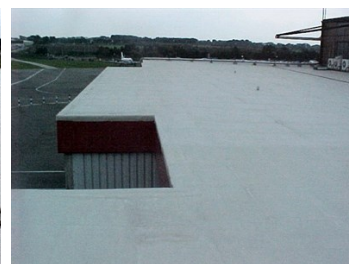
The unusual construction of this roof posed a problem for other roofing systems. Belzona was chosen as the solution, as the alternative was to completely replace the roof. 2 years on and the application is still in perfect condition.
