# BELZONA GRIP SYSTEM HELPS POWER PLANT

Application: SHM-Solids Handling Machinery

Customer Location: Coal Fired Power Plant, Macedonia

Conveyor belt drive roller

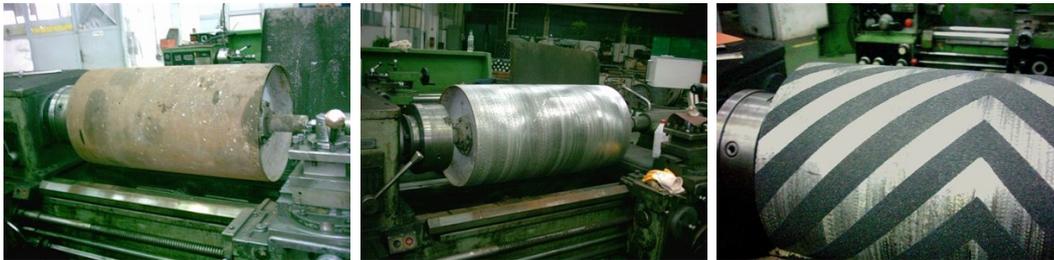
The original rubber lagging had worn away and the loss in friction was allowing the belt to slip and lose efficiency.

- \* Roller in poor condition prior to application ,
- \* Surface preparation ,
- \* Completed application ,

Application was carried out in accordance with Belzona Know-How System Leaflet SHM-12.
