BELZONA REPAIRS HOLED VALVE HOUSING

ID: 699

Customer Location: *Petrochemical Plant, Macedonia*

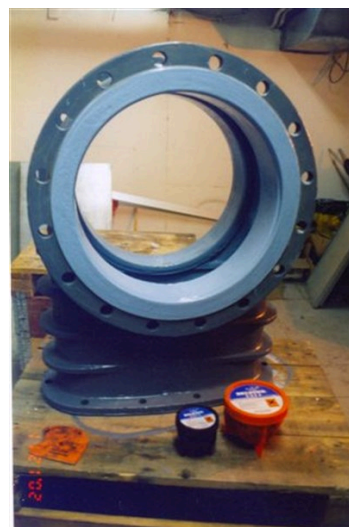
Cavitation had caused the valve housing to become holed

- * Holed valve housing. ,
- * Metal plates used to reinforce the exterior. ,
- * Rebuilt housing. ,
- * Completed application. ,

Application was carried out in accordance with Belzona Know-How System Leaflet VPF-8.

The plant did not have a reserve valve in there warehouse and a new replacement would take weeks to be delivered. Belzona solved the problem in just two days.
