# BELZONA REPAIRS LEAKING TRANSFORMER

ID: 704

Electricity Transformer

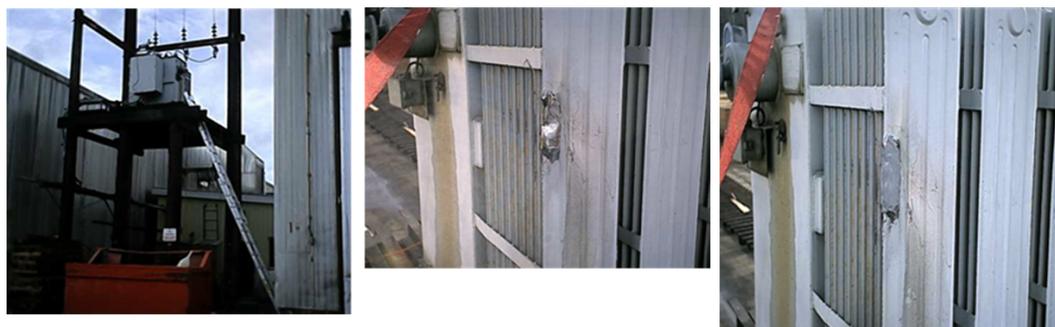
The cooling fins of the transformer had been damaged. Previous repairs lasted only a short while.

- \* View of leaking transformer. ,
- \* Surface preparation completed. ,
- \* After initially sealing the hole with Belzona® 1221 Super E Metal area received a final overcoating layer of Belzona® 1111 Super Metal. ,

Application carried out in accordance with Belzona Know-How System Leaflet VPF-1 and VPF-2.

Rebuilding the damaged area provided a quick and simple solution to a constant problem area and was accomplished with the minimum amount of downtime.
