BELZONA TWO MAIN TURBINE COOLING WATER HEADS

ID: 71

Customer Location: Power Plant in the Midwestern United States

Application: HEX-Heat Exchangers

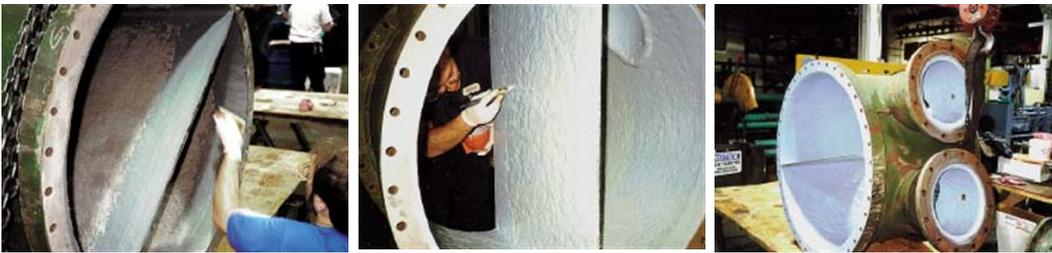
Photograph Descriptions

As the headers feed water through main turbine cooling system, erosion/corrosion damage to divider plates and interior surface occurs.

- * Surface preparation complete, rebuilding eroded areas with Belzona® 1111. ,
- * Application of second coat of erosion/corrosion resistant Belzona® 1341 begins. ,
- * Completed application showing headers repaired and protected. ,

The application was carried out in accordance with Belzona Know-How Leaflets HEX-2 and HEX-3.
