BELZONA REPAIRS A HYDROELECTRIC TURBINE

Customer Location: Hydroelectric Power Plant, France

Application: CEP-Centrifugal Pumps

Problem

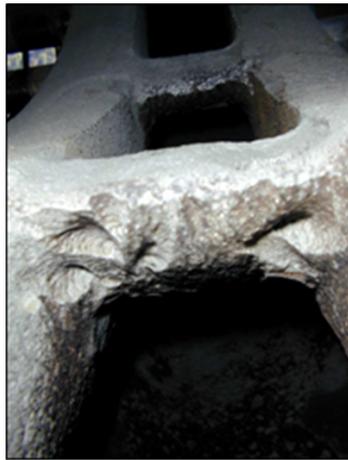
Erosion, corrosion and cavitation of the stay vanes and the casing had induced vibration into the turbine and was also making the turbine run inefficiently.

* 1. The Francis turbine 2. The extent of the damage 3. The completed application 4. Turbine after 11 years in service ,

The application was carried out in accordance with Belzona Know-How System Leaflets CEP-8 & CEP-10.

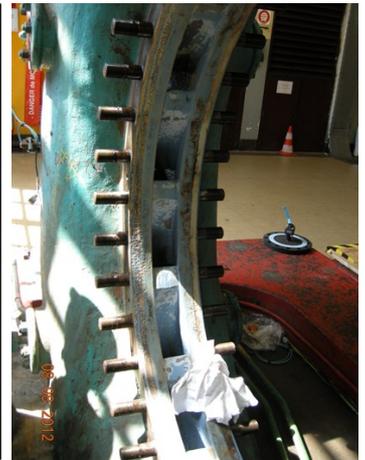
Once back in service the turbine once again achieved its maximum efficiency. The coatings were also chosen to protect the turbine from further damage. An inspection of the turbine following 11 years of service showed that the repair was in excellent condition with only minor damage to the coating, due to erosion from entrained solids, being observed.
