BELZONA REBUILDS AND PROTECTS A BULB TURBINE BODY

Customer Location: *Hydroelectric Power Plant, Drome, France*

Application: *CEP-Centrifugal Pumps*

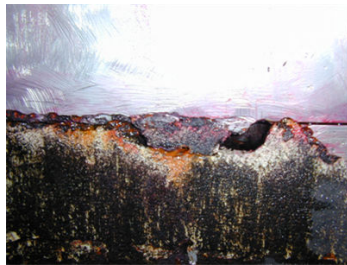
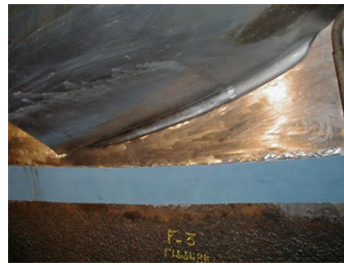
Severe galvanic corrosion between inox and steel leading to water infiltration.

* Application situation The problem The solution ,

The greatest benefit was that the application could be done very quickly, in situ and without hot work. The application of Belzona meant the plant was back in service in the least time possible. Five years later the turbine was inspected and found to be in perfect condition. The galvanic corrosion problem had been completely solved.
