BELZONA REBUILDS AND PROTECTS TURBINE RUNNER HUB

Customer Location: Hydroelectric Power Plant, France
Application Date: July 2003

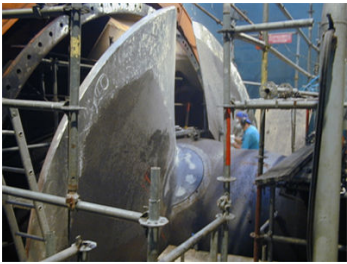
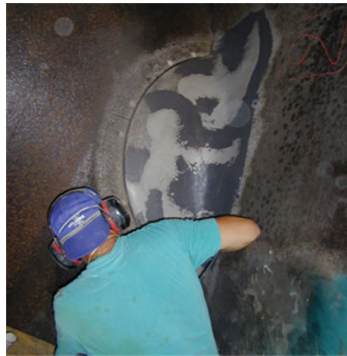
The turbine hub had suffered from erosion due to cavitation.

- * Large Kaplan Turbine ,
- * Application underway ,
- * Completed repair and protection ,

The application was carried out in accordance with Belzona Know-How System Leaflets CEP-5 and CEP-8.

This repair and protection prolonged the life of this turbine and meant that inspection and repairs were required less frequently.
