# BELZONA PUMP CASING REPAIR AND PROTECTION

Application: CEP-Centrifugal Pumps

Customer Location: Power plant , Egypt.

Two diffuser casings from the main circulating water pumps.

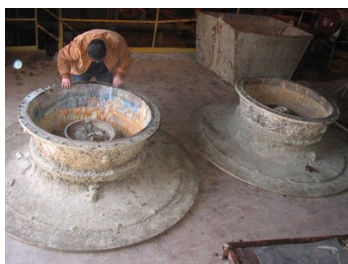
*The two casings were deeply eroded and corroded which affected the pressure and the efficiency of the cooling system.*

- \* The two corroded casings ,
- \* The surface after preparation ,
- \* Rebuilding the surface using Belzona® 1311 ,
- \* Surface protected with Belzona® 1321 ,
